# Property Inspection Report

1234 Fictitious Ave., Utopia, GA 01013

**Inspection Date:**

30/09/2017

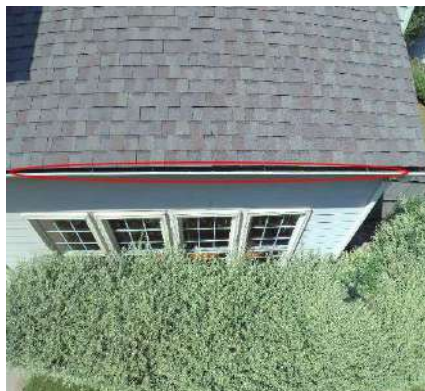
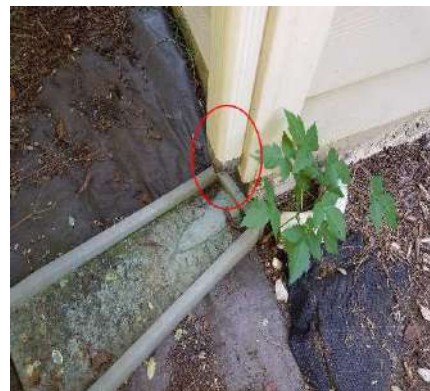
- **Improve:** Covering the gutters with a protective mesh may help to avoid congestion with leaves and debris
- **Repair:** The disconnected downspout at the rear left corner should be re-attached to prevent water accumulation around the foundation.

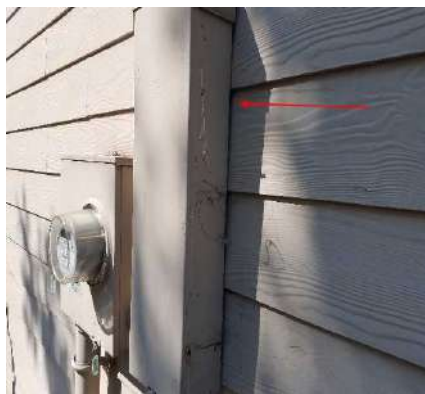
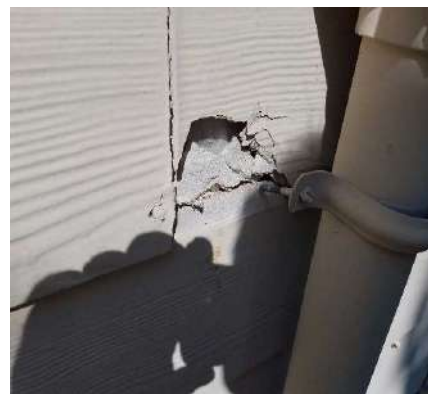
Near Electric Utility Entrance

- **Repair:** Openings in the siding were observed at exterior utility covers. Recommend sealing these areas to prevent moisture intrusion behind the walls.

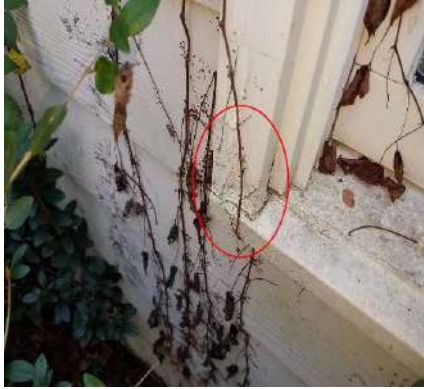
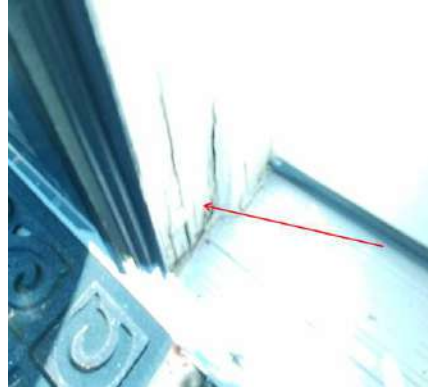
- **Repair:** Some widow and door jam trim as noted at the left side of the house and at the front door show evidence of rot to the frames. Repair to the frames can usually be accomplished by a skilled carpenter.

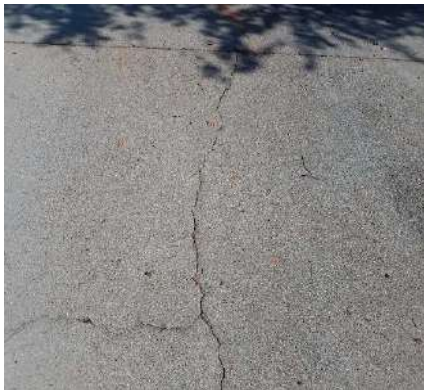
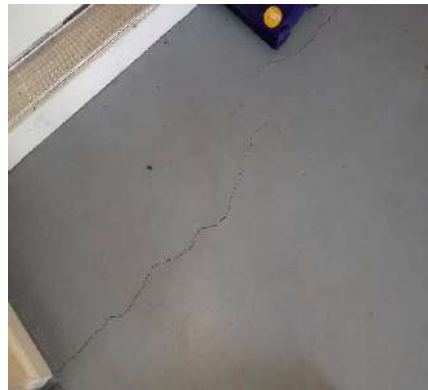
- **Monitor:** The soil below the driveway and in the garage has settled slightly resulting in surface cracks. These cracks are not considered significant and in the absence of additional cracking, repair should not be necessary.

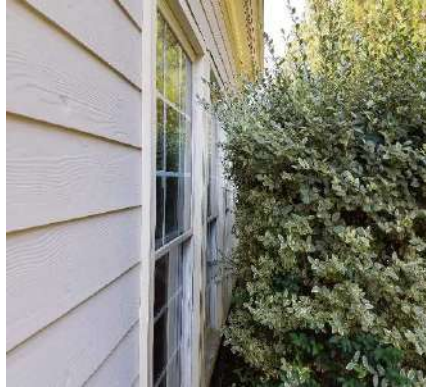
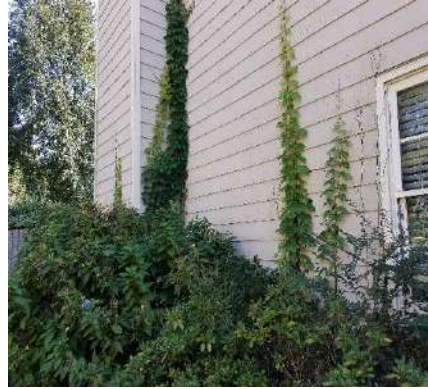
- **Repair:** Bushes and vines should be trimmed away from the house to avoid damage to the building from water and insects..

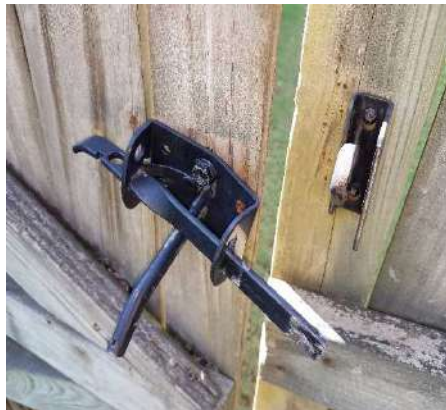
- **Repair:** The gate latch mechanism needs repair to function properly.

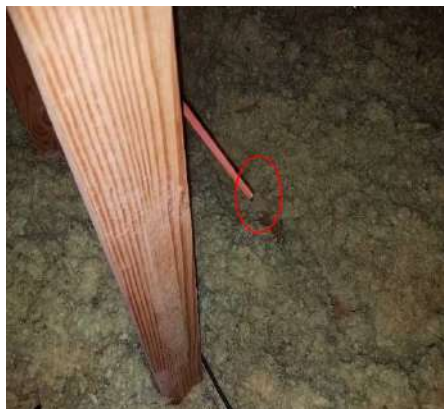
- **Safety issue:** An abandoned wire as noted in the attic across from the furnace units should be removed or appropriately terminated with a box and cover.

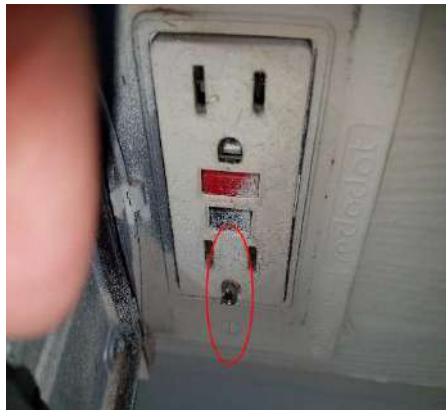
- **Repair:** A grounding pin has broken off inside the outlet located at the rear patio. Recommend an electrical contractor repair or replace this receptacle.

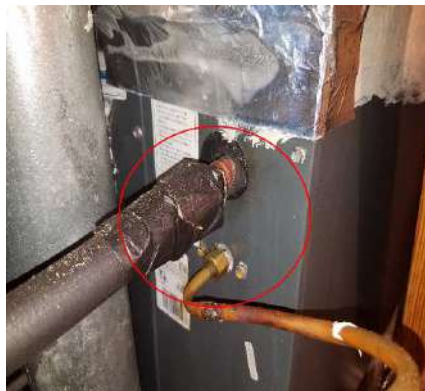
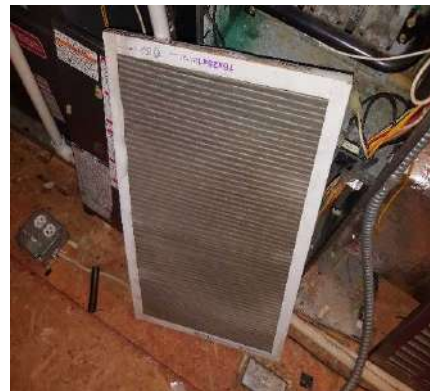
- **Repair:** The dirty air filter should be replaced.

- **Repair:** The openings in the furnace casings where the refrigerant lines enter the units should be sealed to prevent the loss of conditioned air which reduces efficiency and increases operating costs (See Photos).

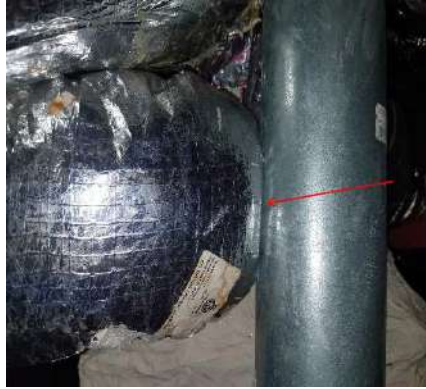
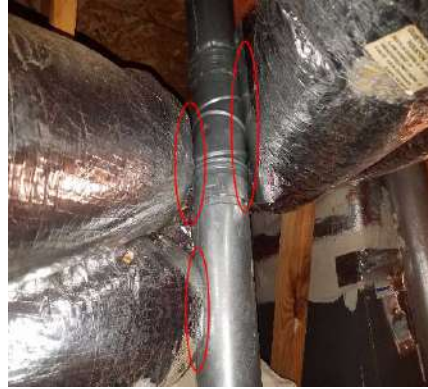
- **Safety issue:** There is insufficient clearance between the exhaust flues on the furnaces and combustible materials (ductwork). A minimum of 1 inch clearance is typically required or a metal shield installed). Recommend a metal shield or collar be installed as this is a potential fire hazard.

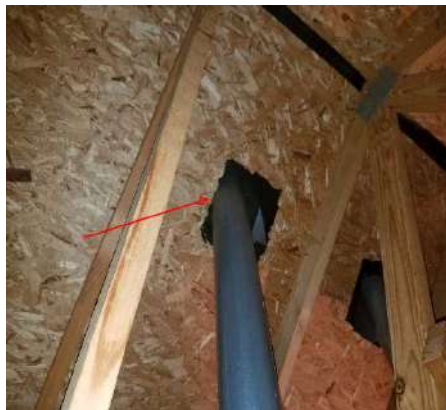
- **Safety issue:** There is insufficient clearance between the exhaust flue and combustible materials as noted where the roofing material is against the flue at the roof line (a minimum of 1 inch clearance is typically required). This is a fire hazard, and should be corrected.

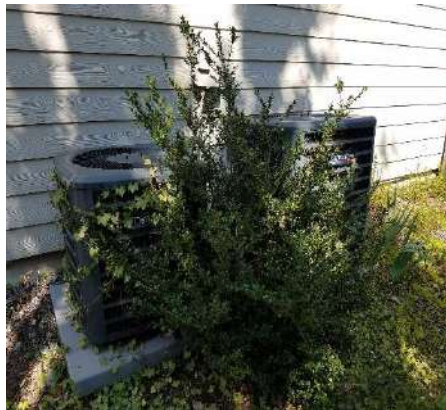
- **Repair:** Vegetation in the vicinity of the outdoor unit of the air conditioning systems should be cut back to improve ventilation and overall efficiency of the systems.

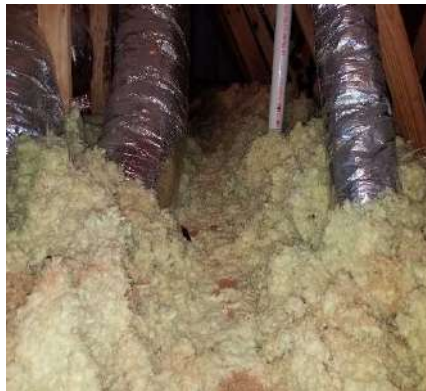
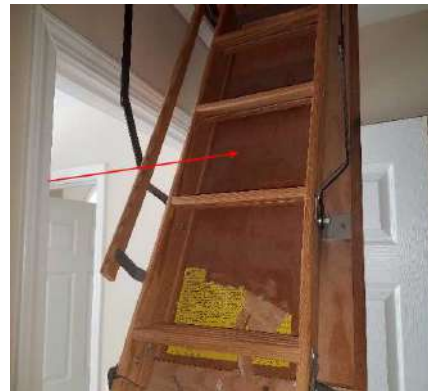
Insufficient Insulation

- **Improve:** The attic insulation should be improved in some areas to achieve R30, which is the present day standard. Any missing attic insulation such as noted to the right of the attic stairs should be replaced for proper protection against loss of conditioned air into the attic. The pull-down attic access door should be insulated with foam board and weather stripped to limit unconditioned air infiltration into finished areas.

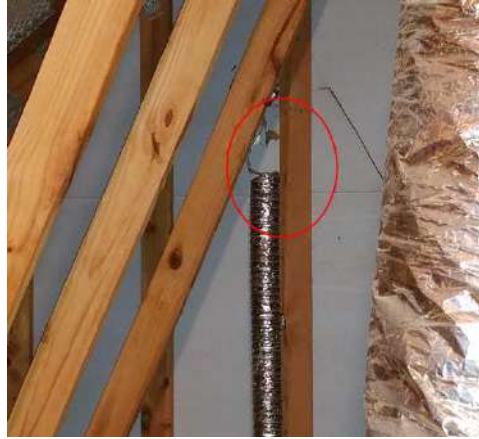
- **Improve:** Exhaust vent pipes from the bathroom venting into the attic space should be vented to the building exterior.

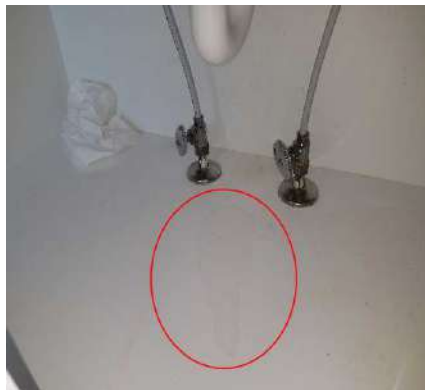
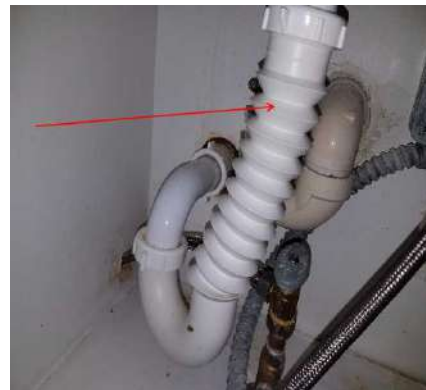
- **Repair:** There is a flexible drain pipe located under the kitchen sink which is prone to clogging. Recommend replacing with rigid smooth walled pipe per proper plumbing technique.

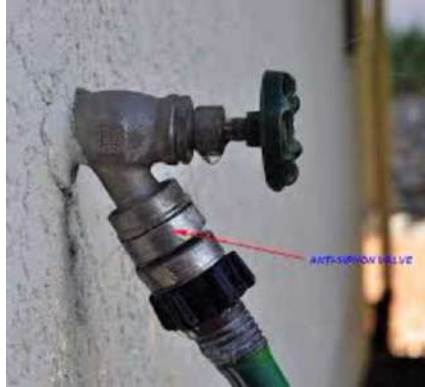
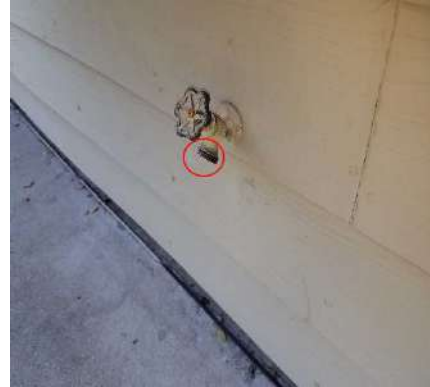
- **Improve:** To reduce the risk of contamination of supply water, installation of anti-siphon devices on exterior hose bibs would be wise.

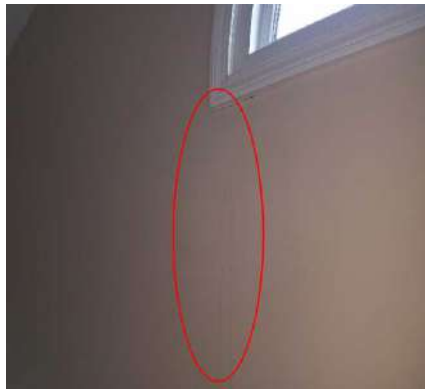
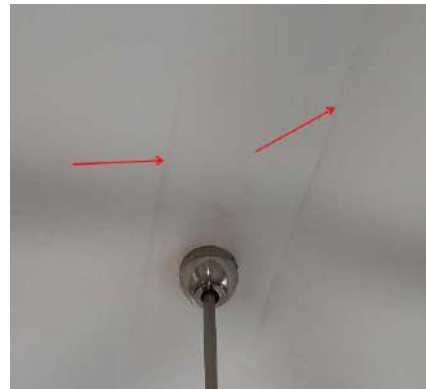
- **Monitor:** An apparent water staining was noted at the master bedroom wall below the fixed pane window. The area was dry at the time of the inspection, but leakage could not be definitively ruled out based on a one time visit to the home. Recommend consulting with the current owners for additional information prior to closing. If the leak is still active, recommend repair/replace as needed to remedy the leak.
- **Monitor:** Minor damage to the interior finish was observed (drywall tape deterioration) at the peak of the master bedroom ceiling. These blemishes are normally the result of the settlement process. Repair is optional (See Photo).

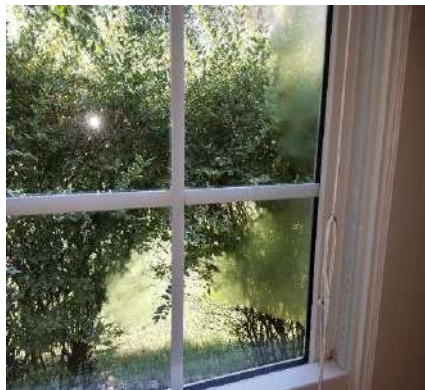
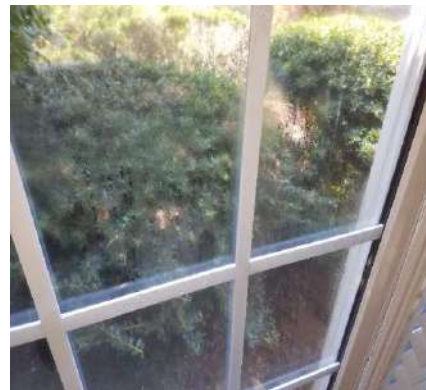
- **Monitor:** Double pane windows in the family room and living room appear to have lost their seals (condensation forming in between the glass). Cloudiness will persist and likely worsen over time. It is a condition that cannot be repaired in a practical manner. Replacement of the windows may be needed (See Photos).

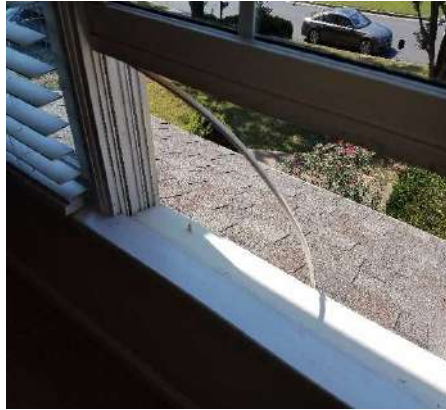
- **Repair:** The weatherstripping for the right window in the front middle bedroom is damaged and requires repair to

reduce utility costs.

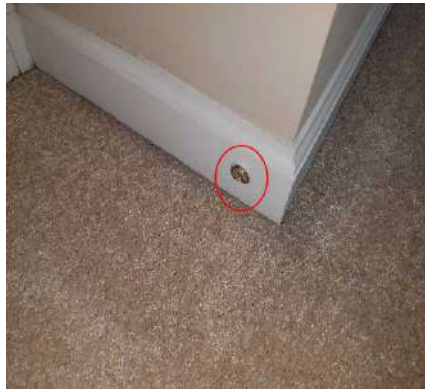
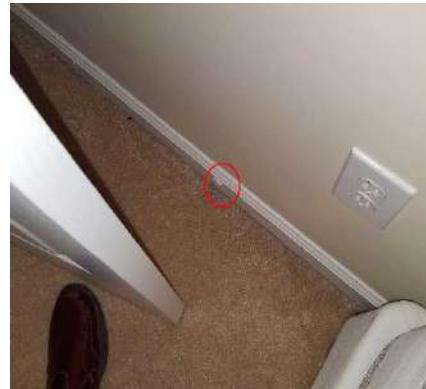
- **Repair:** Door stops are recommended for all doors to prevent wall damage.

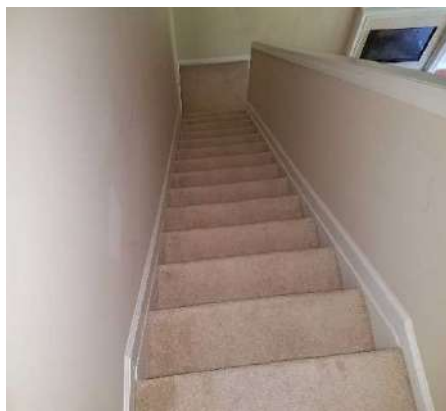
- **Safety issue:** For improved safety, it is recommended that a graspable hand rail be provided for the back stairway.

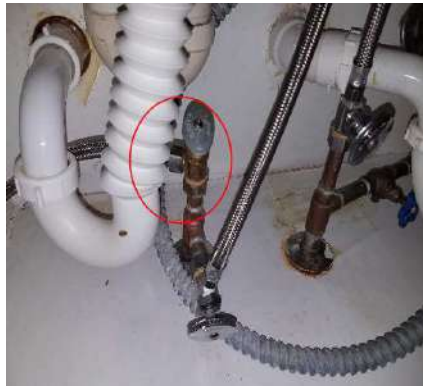
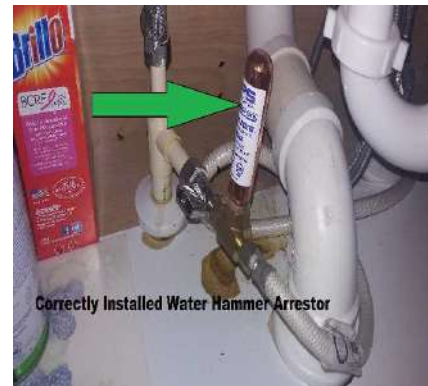
- **Improve:** A water hammer arrestor is missing for the dishwasher. A water hammer arrestor is recommended wherever quick closing valves are utilized.

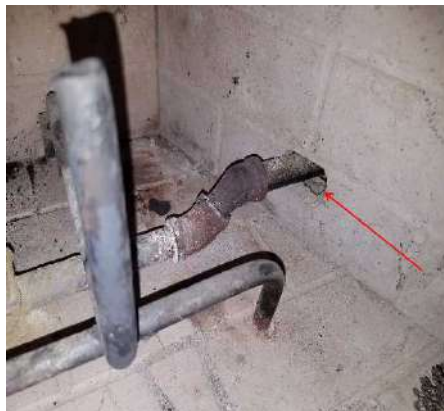
- **Repair:** The hole in the firewall around the gas line penetration to the fireplace is not sealed. Recommend sealing this opening with a non-combustible filler.
