# Property Inspection Report

1234 Fictitious Ave., Utopia, GA 01013

**Inspection Date:**

30/09/2017

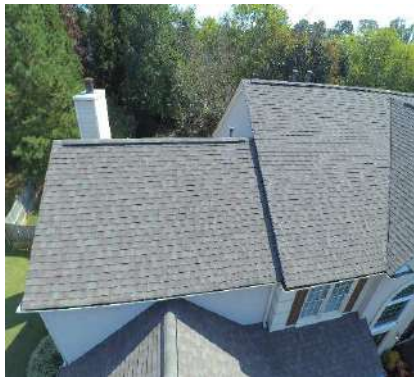
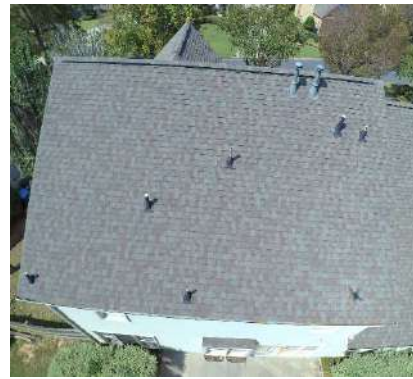
General Roofing Photos

The roofing is somewhat newer material (reported age is two years) and is in good condition. The typical life for this material is 30 years. In all, the shingles show evidence of normal wear and tear for a roof of this age. Keep in mind that these life expectancies are approximations only and other factors such as extreme weather conditions can result in a shorter life.

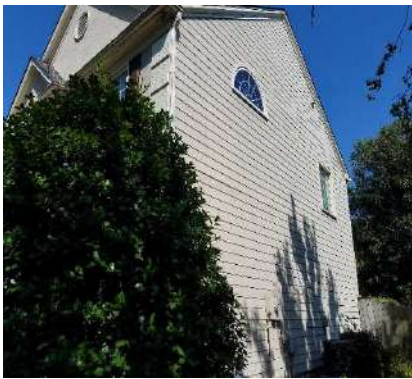
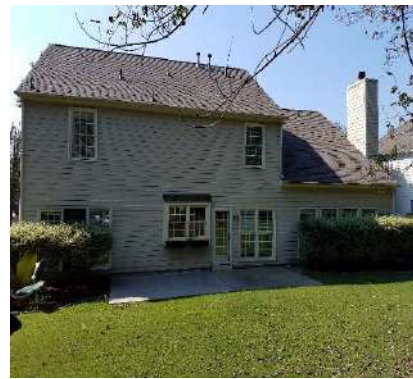
General Exterior Photos

The exterior fiber cement siding that has been installed on the house is a durable material and requires relatively low maintenance. The window frames and siding trim are in generally good condition. The driveway and walkways are also in good condition.

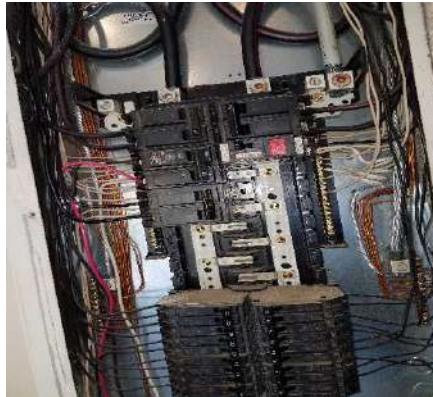
The size of the service ( 200 amps) appears to be sufficient for typical electrical requirements of a home this size. Inspection of the electrical system did reveal the need for typical, minor repairs. A licensed electrician should be consulted to undertake the repairs recommended below and to evaluate the entire system for further repairs that may be needed.

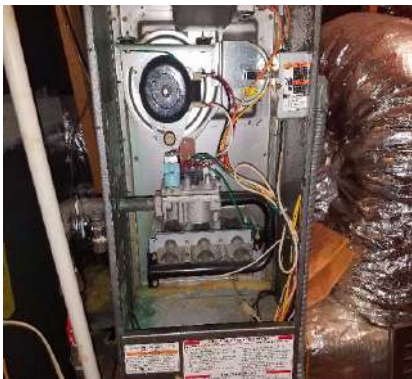
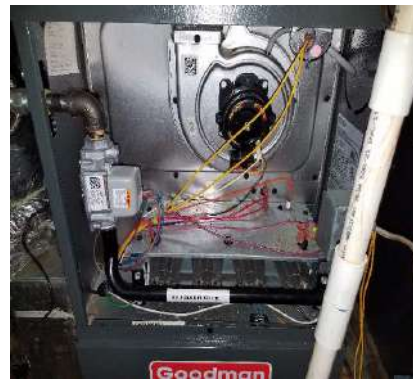
General Furnace Photos

The furnaces appear to be approximately 6-22 years old based on the serial numbers. The typical life for such units is 20-25 years based upon proper maintenance scheduling. The furnaces responded to normal operating controls at the time of inspection. Adequate heating capacity is provided by the systems and heat distribution within the home is adequate.

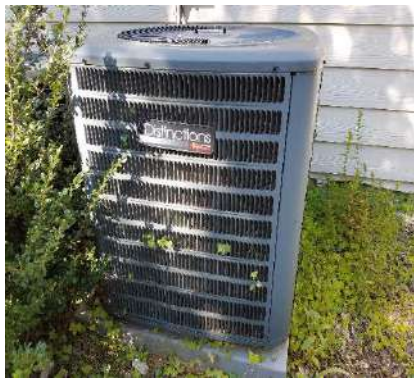
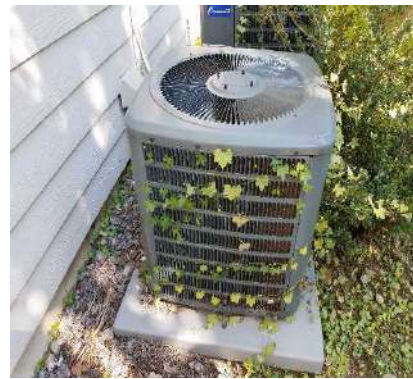
General Condensing Unit Photos

The outdoor units appear to be approximately 5-6 years old based on the serial numbers. The typical life for such components is 12-15 years based on proper maintenance scheduling. Upon testing in the air conditioning mode, a normal temperature drop across the evaporator coil for the upstairs unit was observed. This suggests that this system is operating normally.

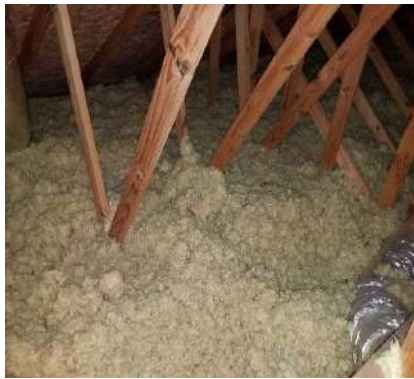
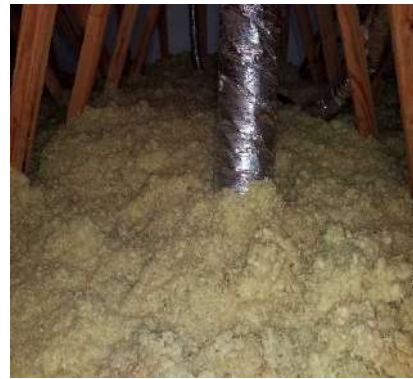
General Insulation Photos

Overall, this is a well insulated home. Any further insulation improvements will help to reduce utility costs.

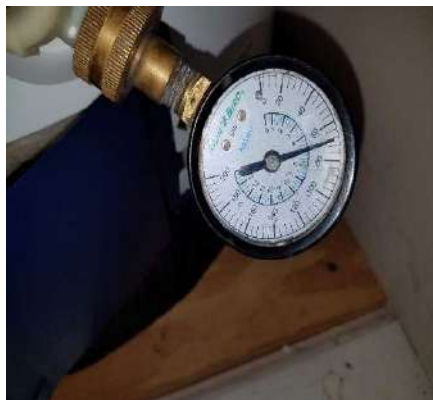
Water Pressure Reading

The water pressure supplied to the fixtures is 70 psi which is reasonably good. A typical drop in flow was experienced when two fixtures were operated simultaneously. Overall, the plumbing system is in generally good condition with only minor repairs or improvements recommended. The plumbing fixtures appear to have been well-maintained.

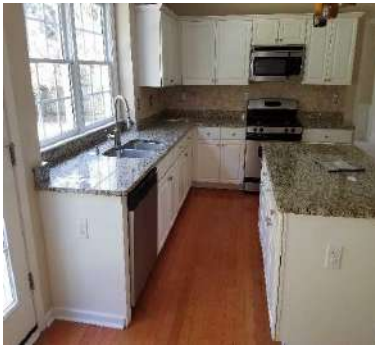
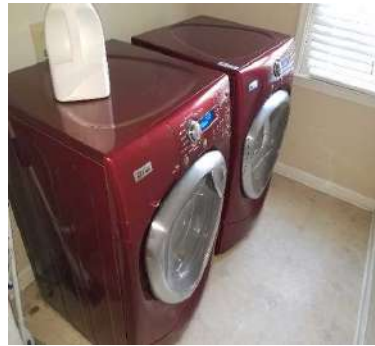
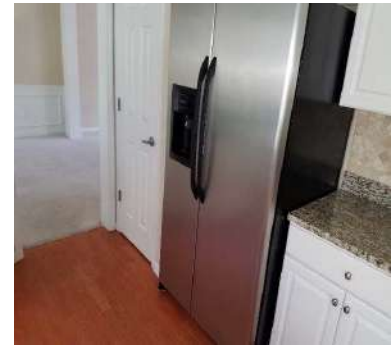
Most of the appliances were in good working order. Improvements are needed as specified below.

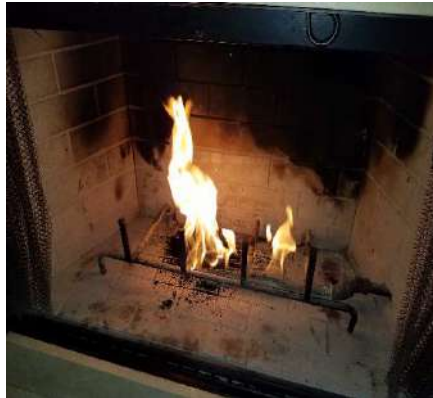
The fireplace appears to be in above average condition. The damper operates correctly and the firebox does not show signs of excessive wear.

- **Repair:** The hole in the firewall around the gas line penetration to the fireplace is not sealed. Recommend sealing this opening with a non-combustible filler.
